Facility Summary

TOWN OF MERRIMACK, NH
MERRIMACK, NEW HAMPSHIRE 03054

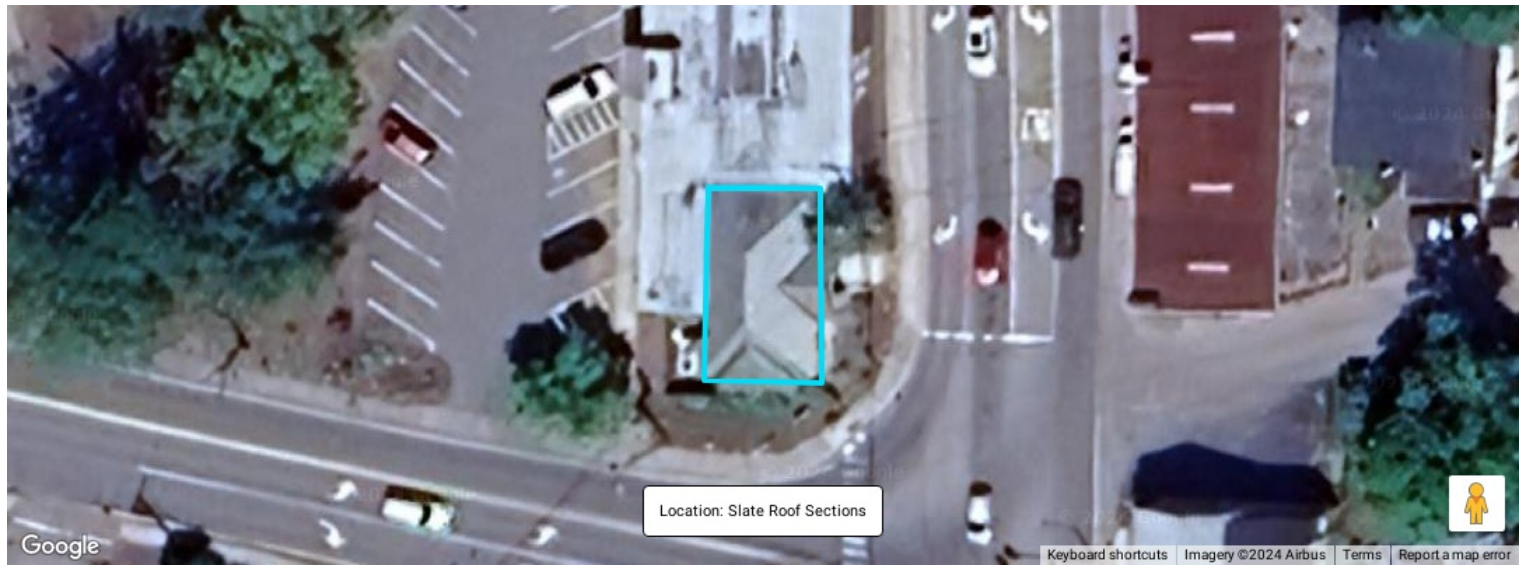
Inspection Information

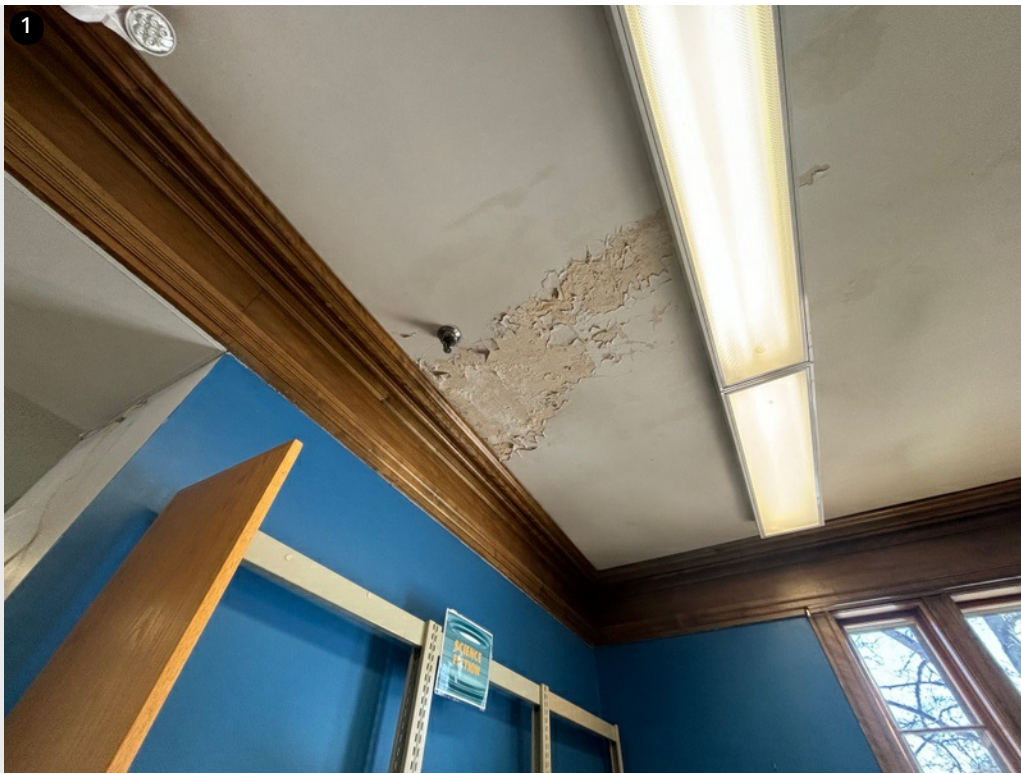
1 Interior leak presenting under the Northern facing section of slate roof.

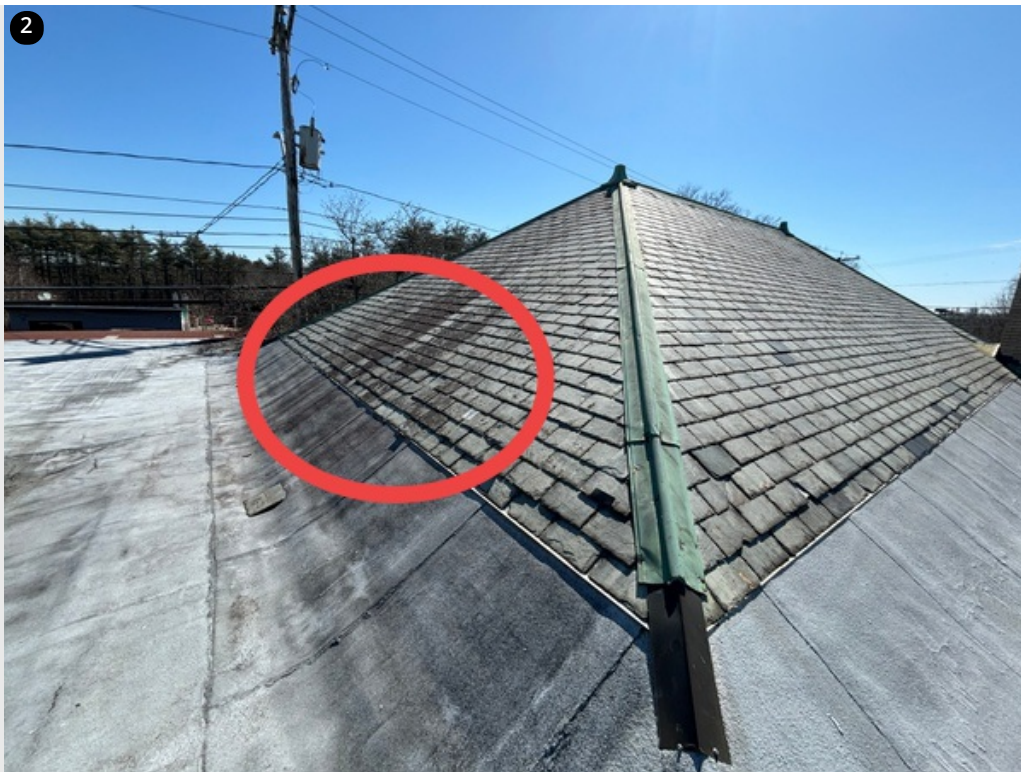
2 Leak area highlighted. Overview photo of Northern most slate roof section. Slate missing and damaged throughout all slate roof sections.

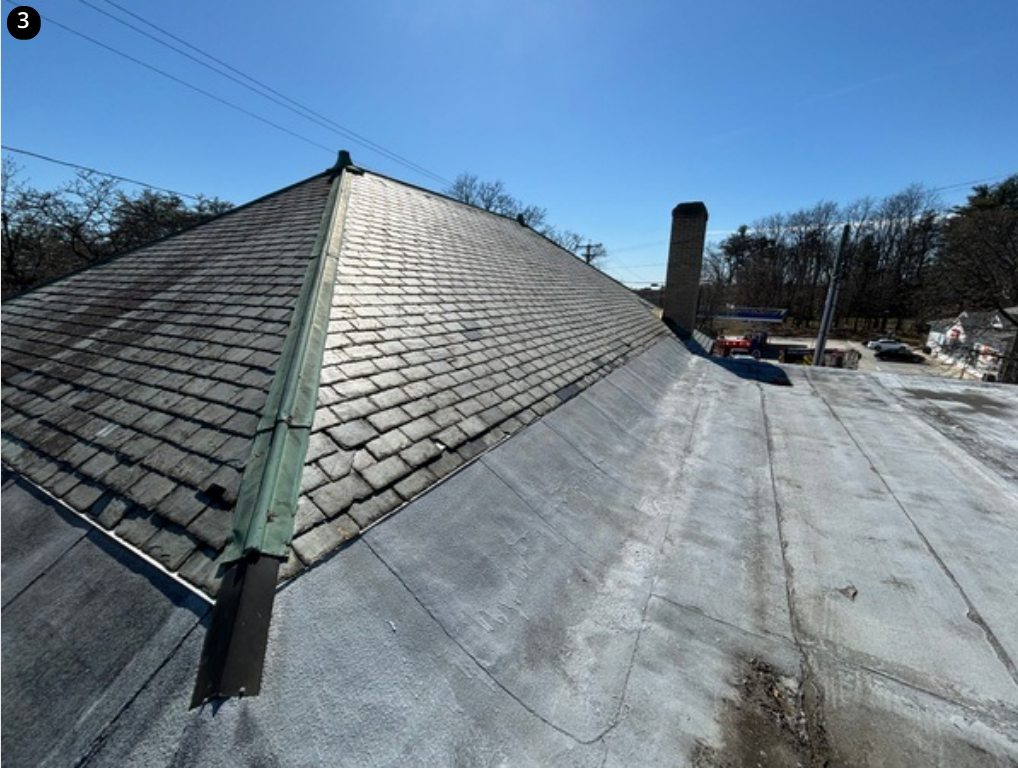
Overview photo facing South.

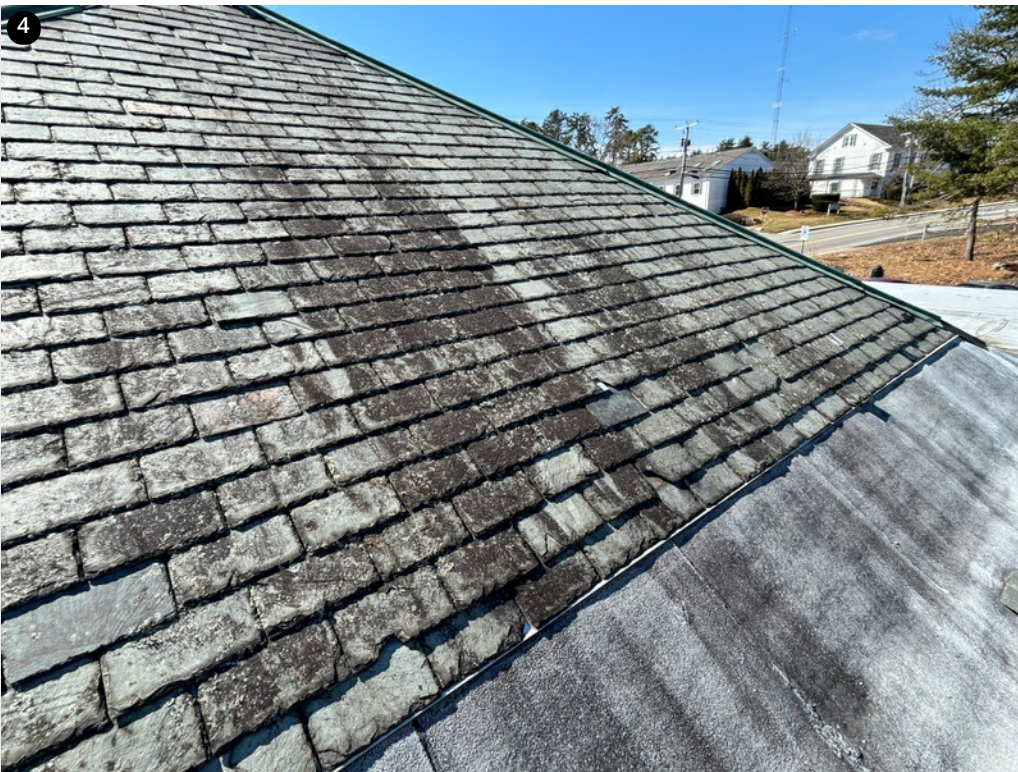
Overview photo of above leak area. Deterioration found throughout slate roof sections.

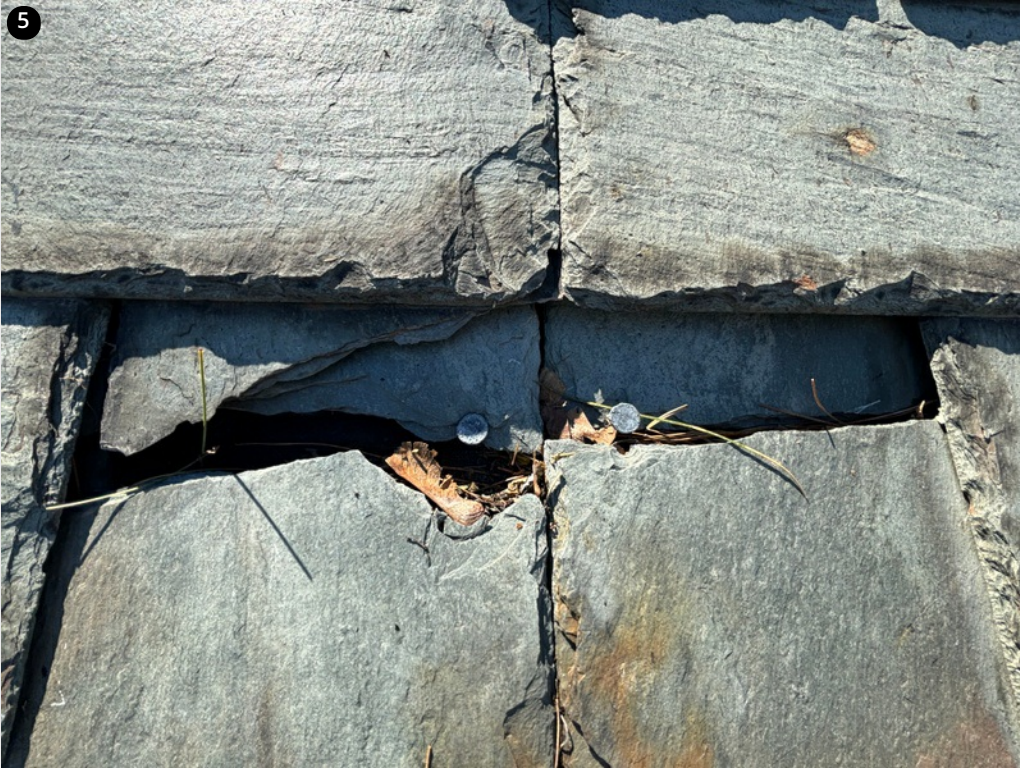
Exposed fasteners above leak area.

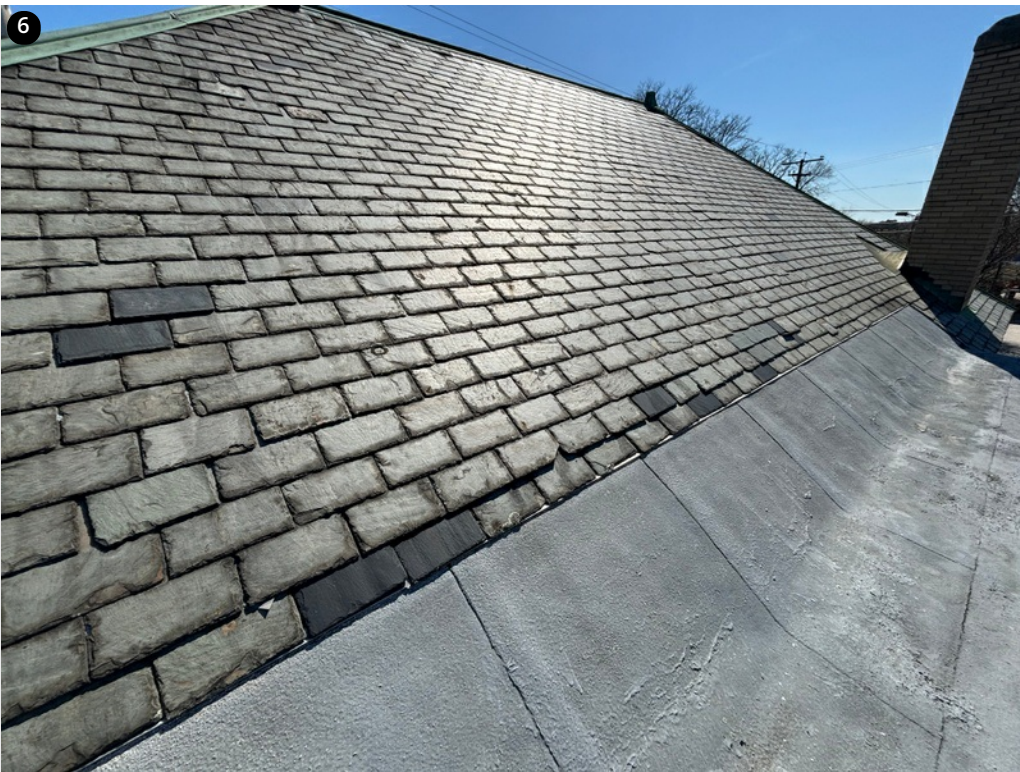
Overview photo of the Western facing slate roof section.

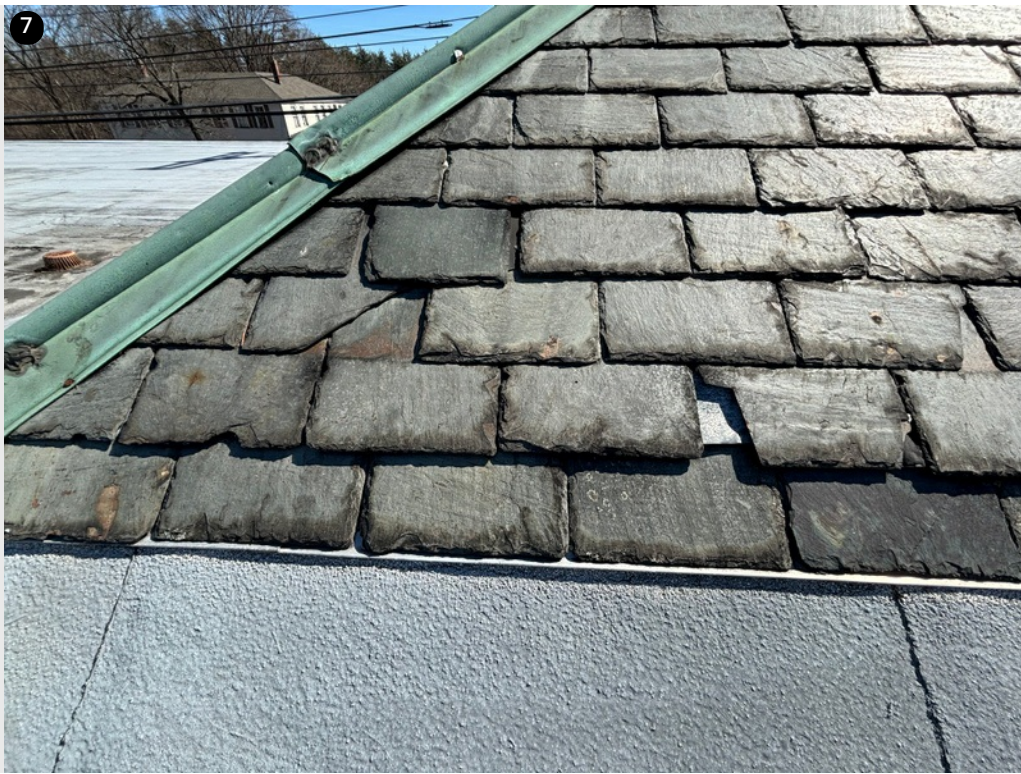
Broken slate on Western facing section.

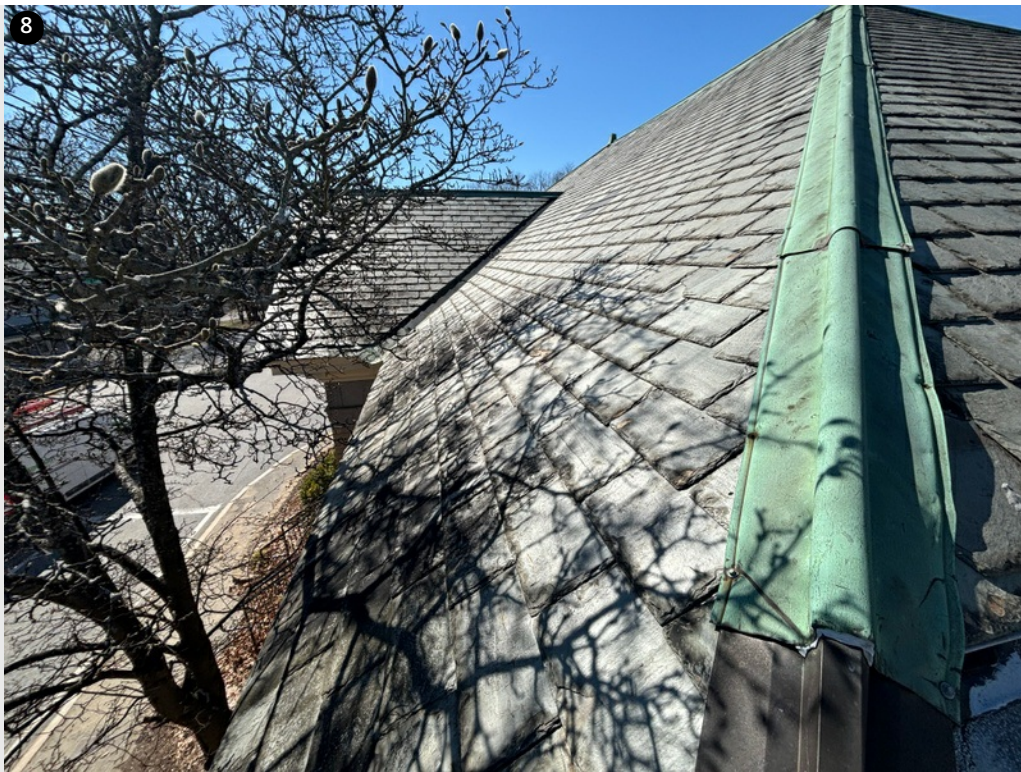
Overview photo of the Eastern facing slate roof section.

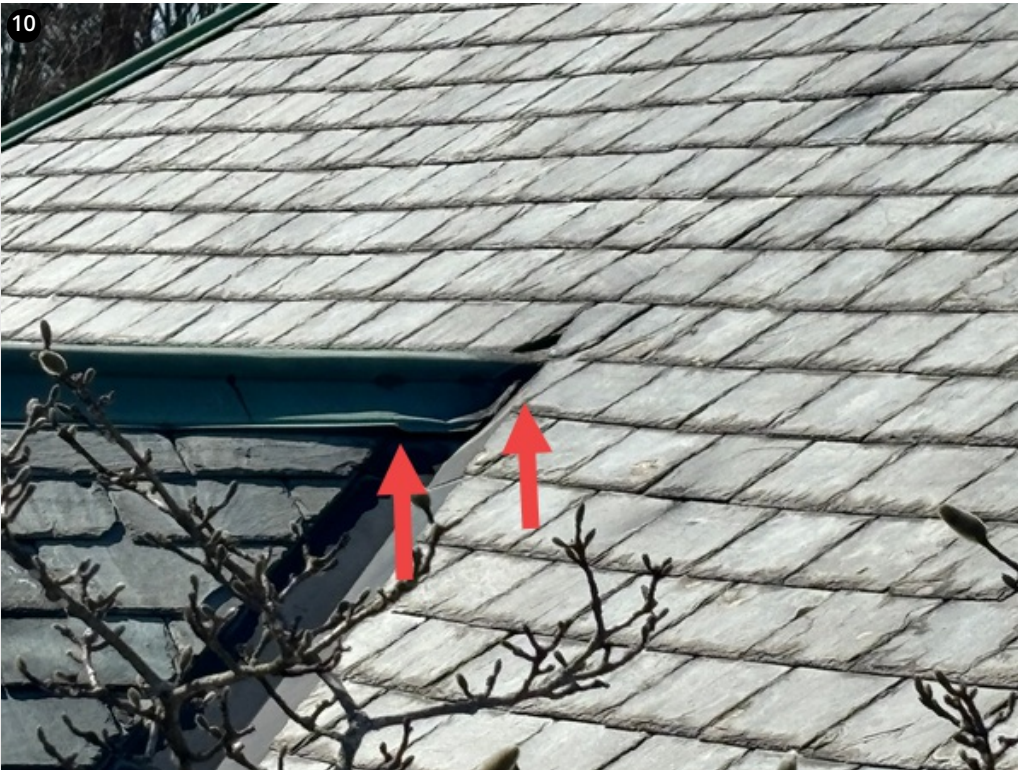
Open conditions throughout edge metal.

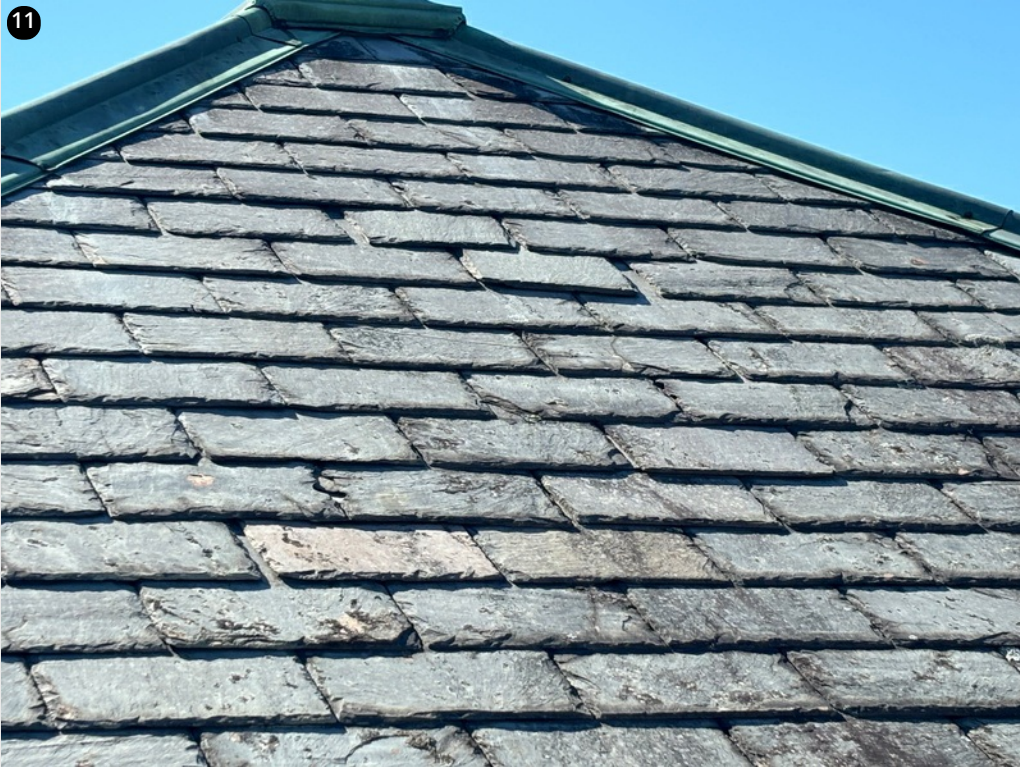
Loose slate throughout roof sections.

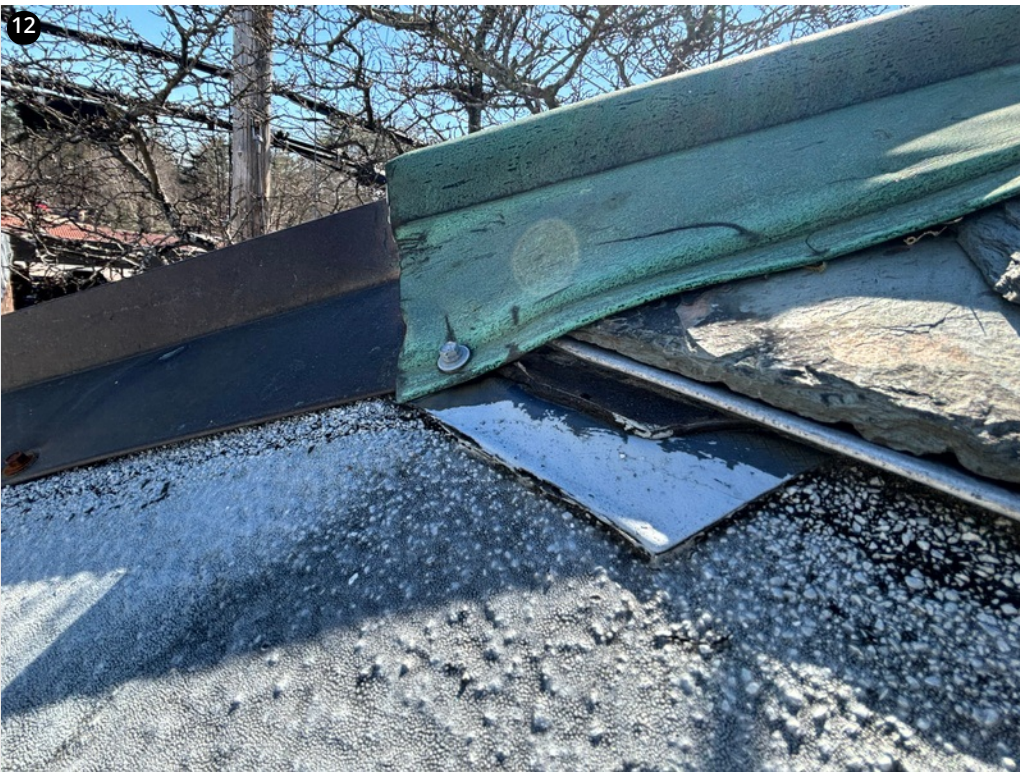
Open conditions throughout edge metal.

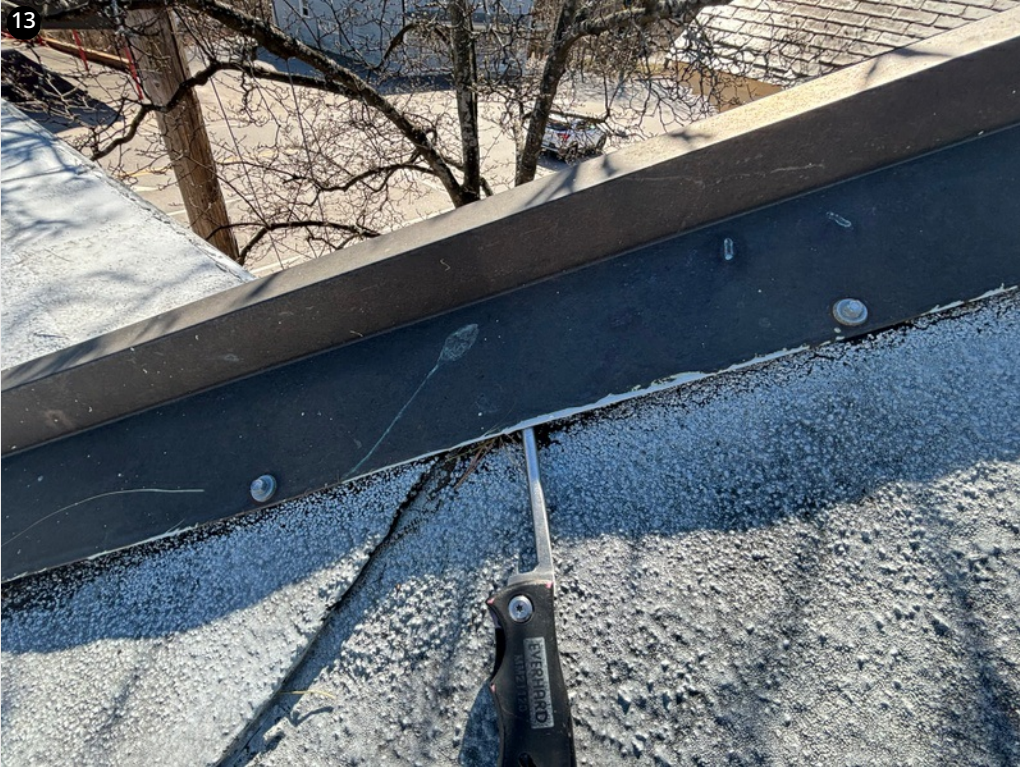
Open conditions throughout edge metal.

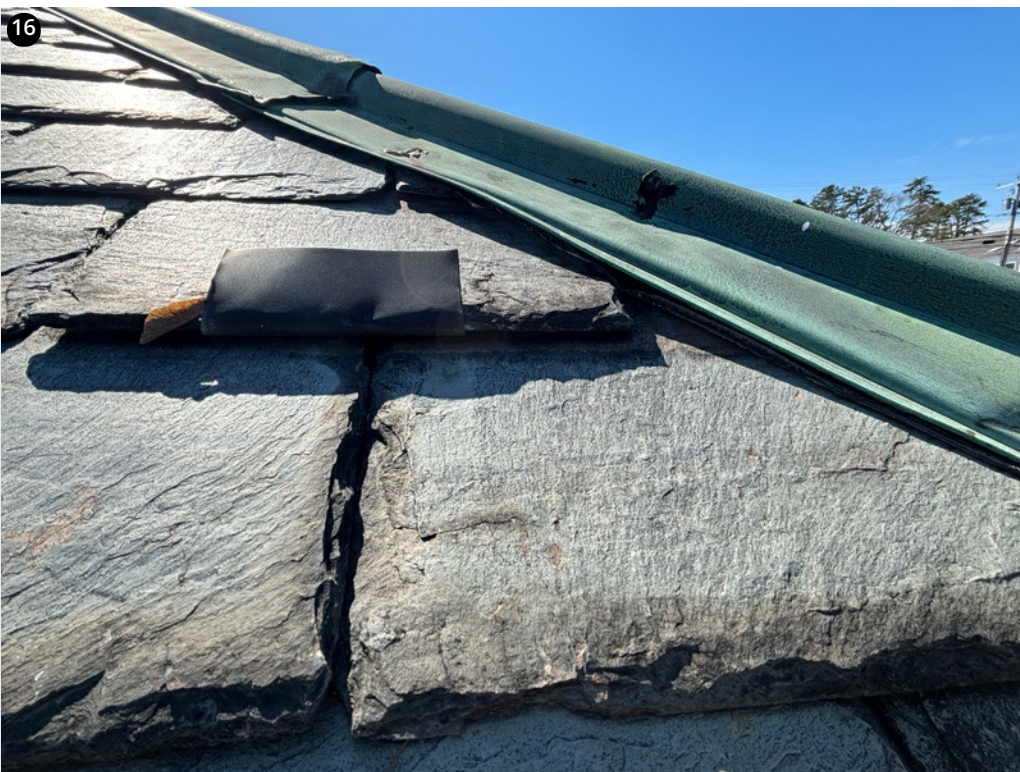
Areas throughout edge metal not secured.

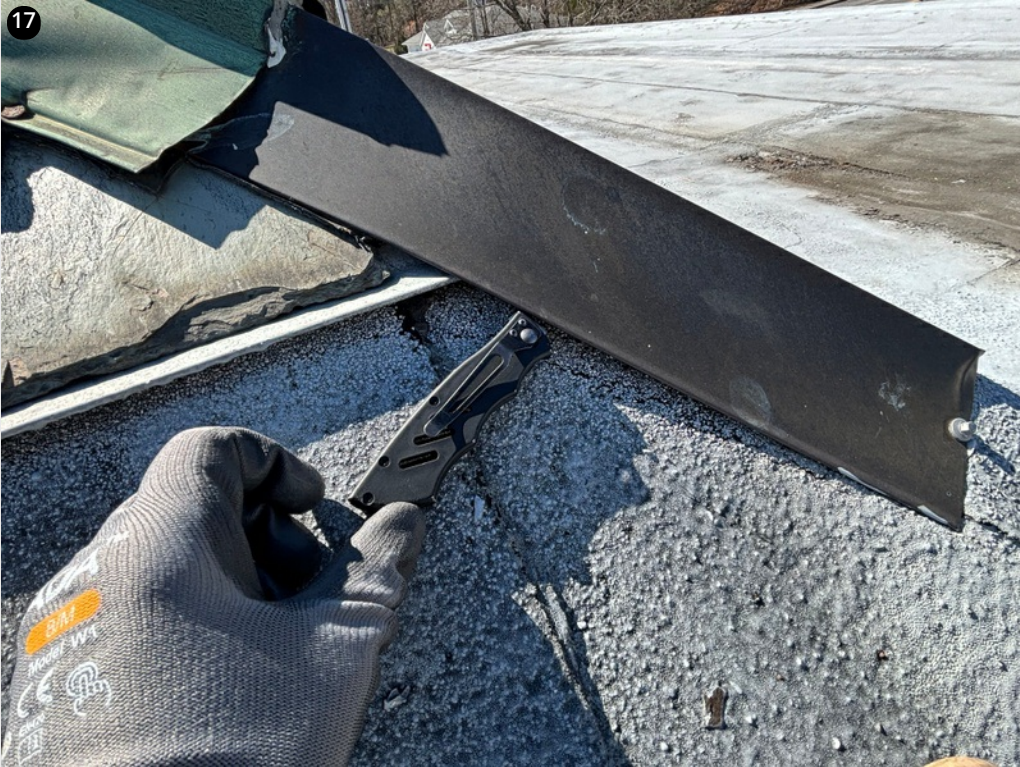
Open conditions at transition.

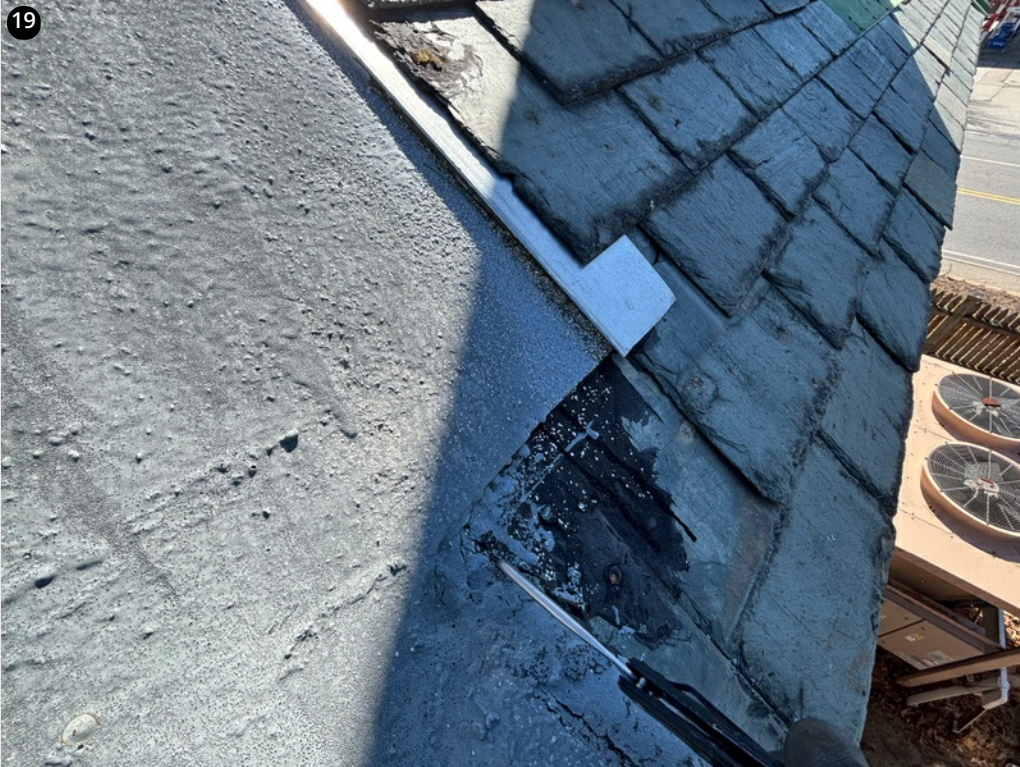
Open conditions throughout slate to modified transitions.

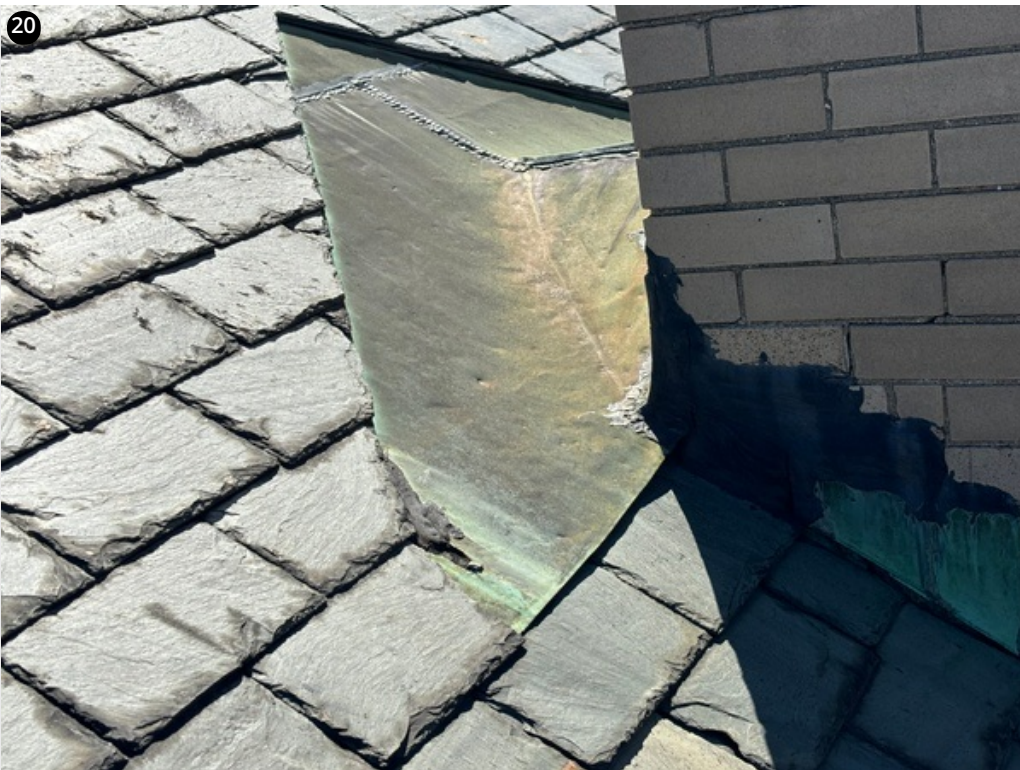
Possible open conditions at flashing detail.

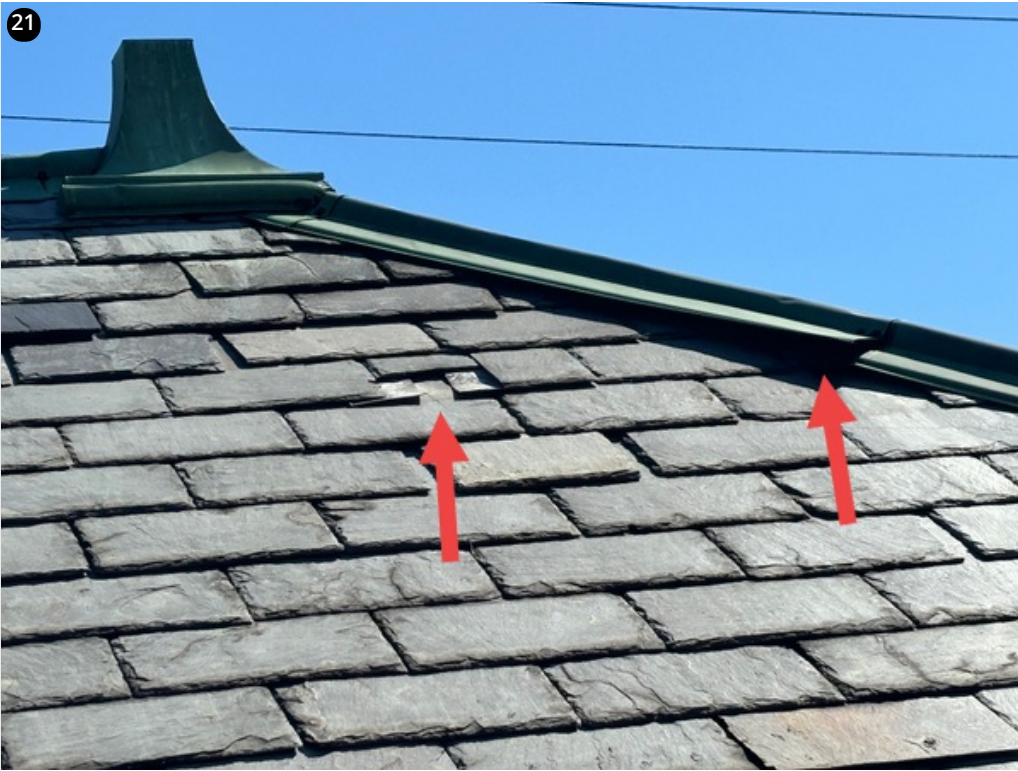
Slate shingle shifted and edge metal lifting.

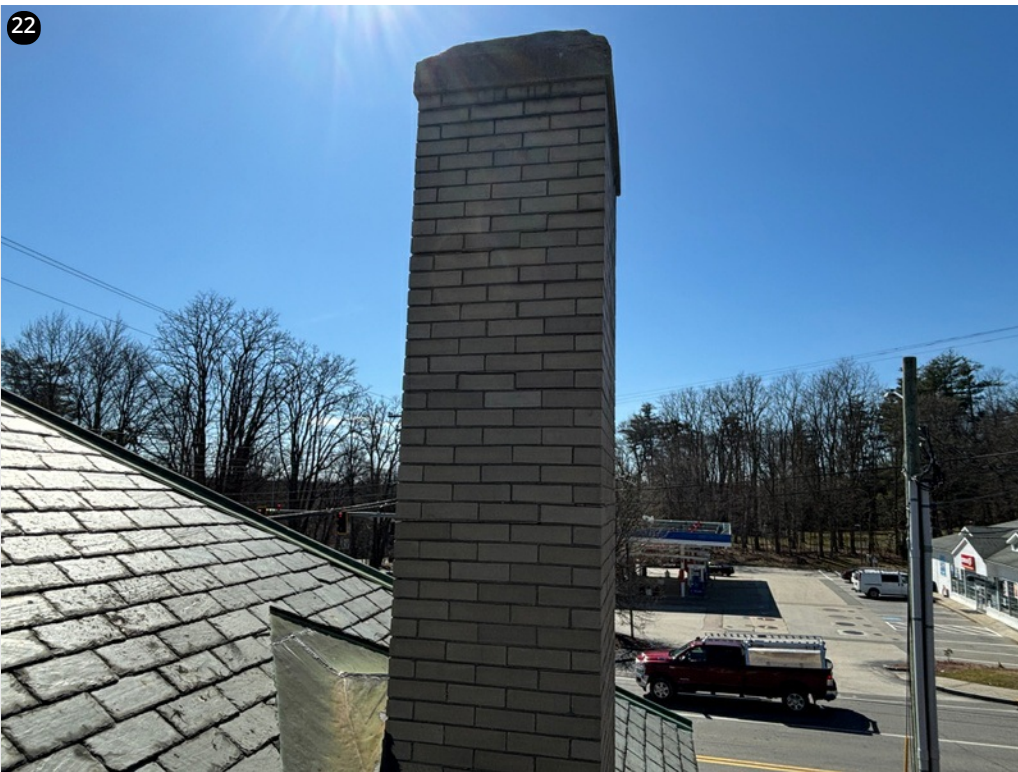
Masonry joints on chimney are showing deterioration.

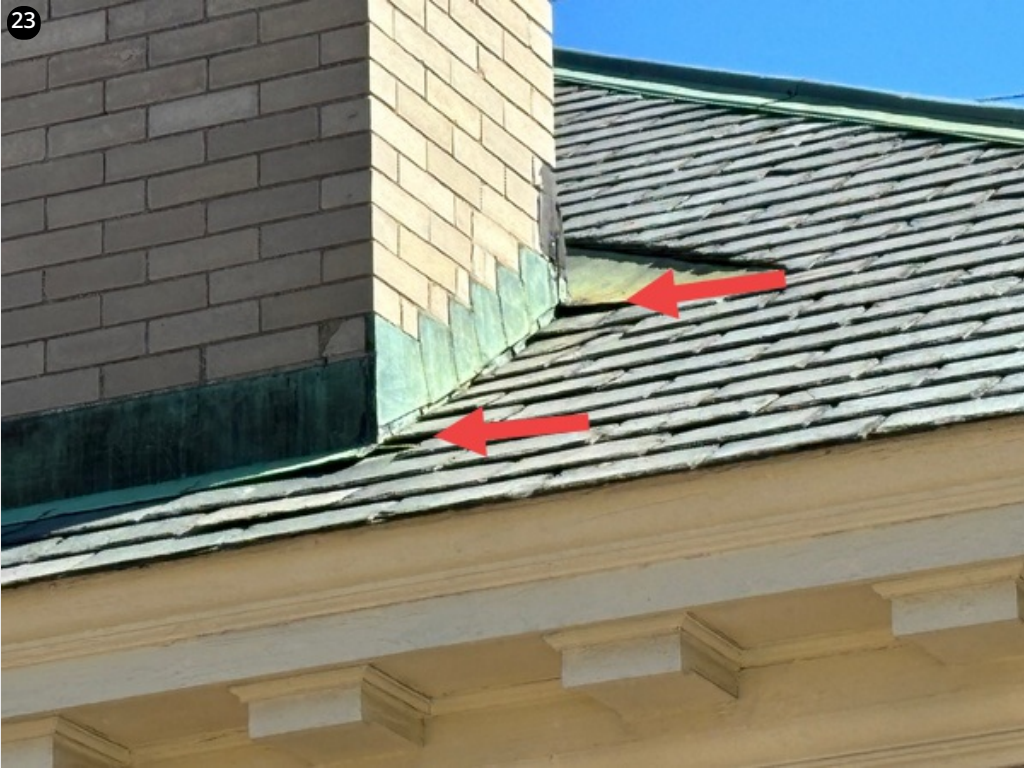
Possible open conditions around masonry step flashing.

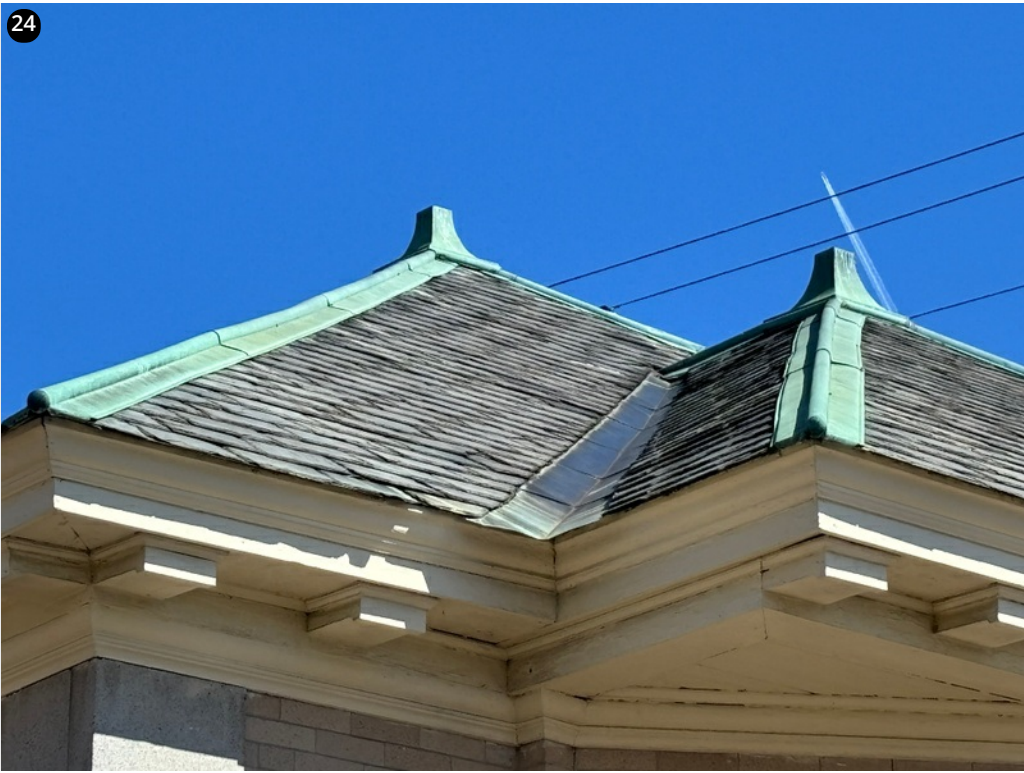
Photo showing South facing slate roof section.

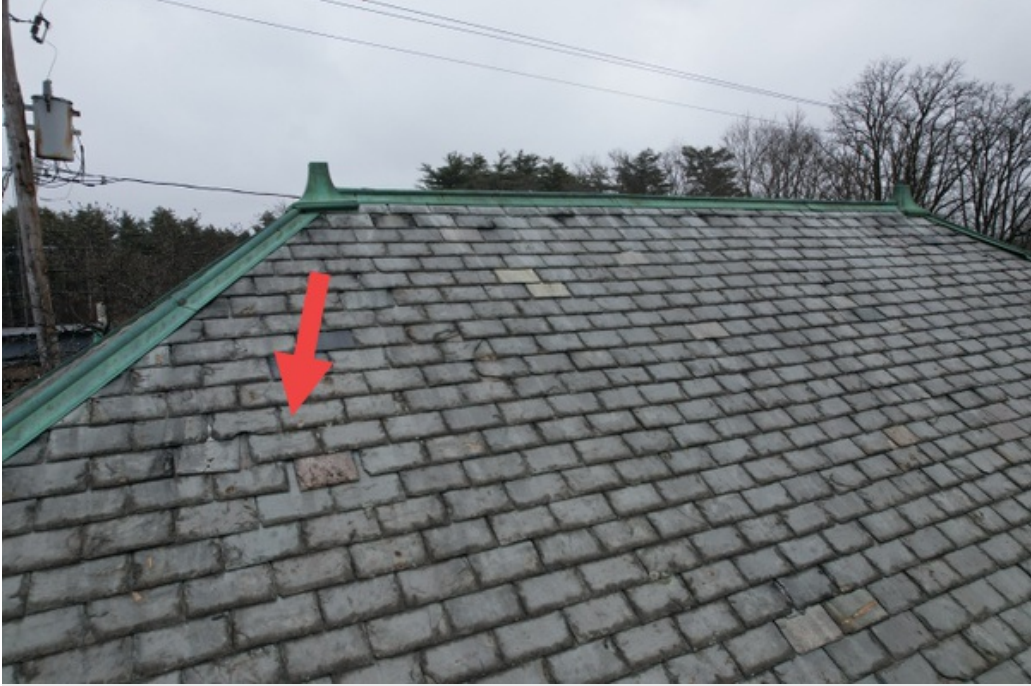
Area of loose slate.

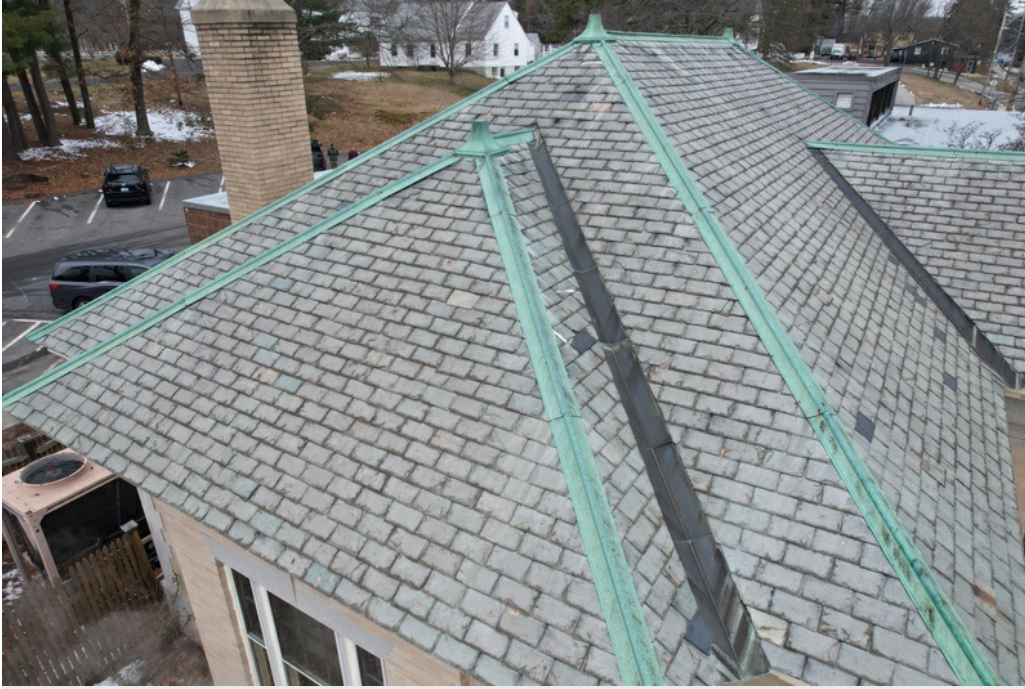
Overview of slate roof.

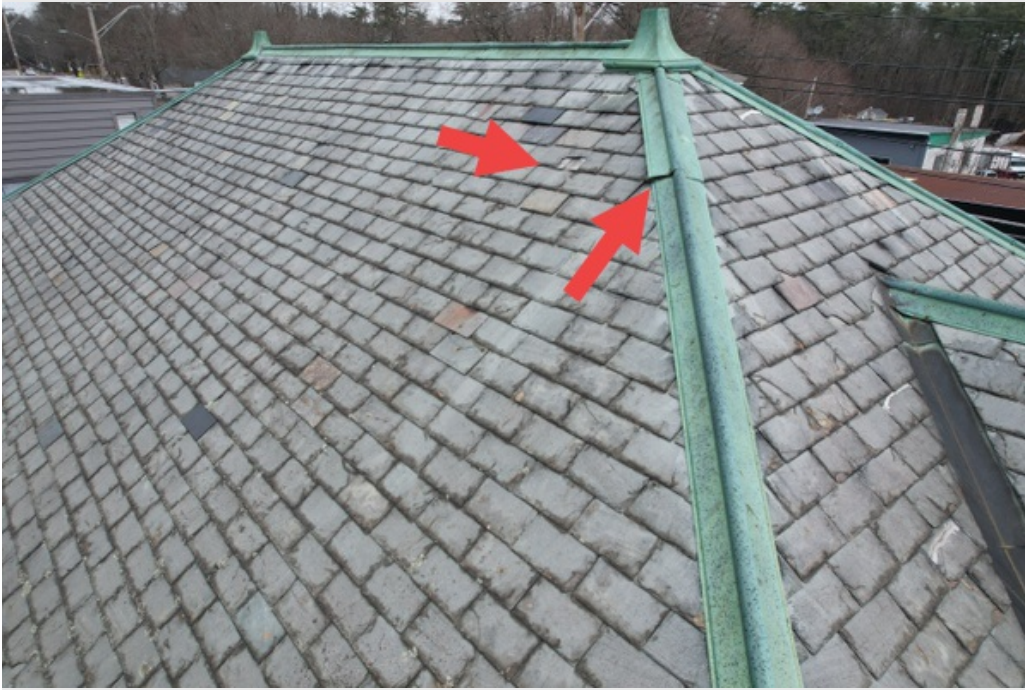
Loose metal cap.
Missing slate.

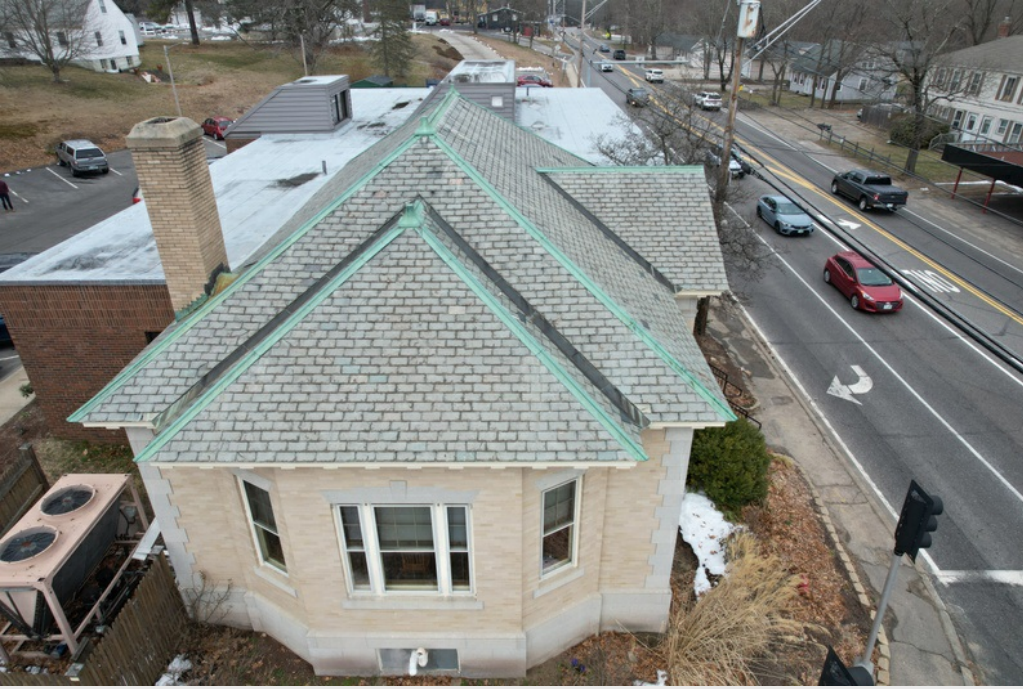
Overview of slate roof.
