Wire Road Engineering Study & Public Presentation

**US Route 3 / Wire Road Intersection  
Safety & Capacity Improvements  
NHDOT Project No. 41588  
Merrimack, New Hampshire**

# Wire Road at US Route 3 Intersection & Roadway Safety Improvements

*NHDOT Project No. 41588*

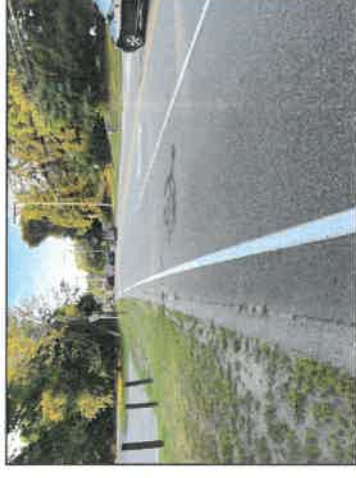
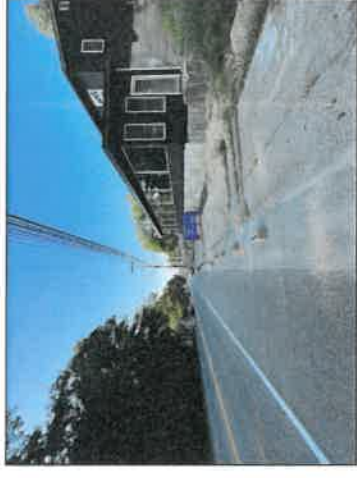
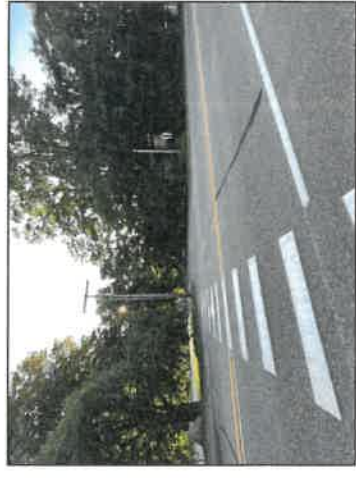
- Scoping Session
- Design Criteria
- Existing Conditions
  - ✓ Project Corridor is approximately 1300 Linear Feet.
  - ✓ Existing Right-of-Way is approx. 66 feet wide and widens at Wire Road intersection.
  - ✓ Two 12-13 foot travel lanes, two 6-foot shoulders, 10-11 foot turn lane.
  - ✓ Limited sight lines for egress from Wire Road.
  - ✓ Church Street intersects US Route 3 at 15% grade.
  - ✓ Utilities – aerial utilities on west side, watermain, gas line, drainage and telecommunication and fiberoptic underneath US Route 3.

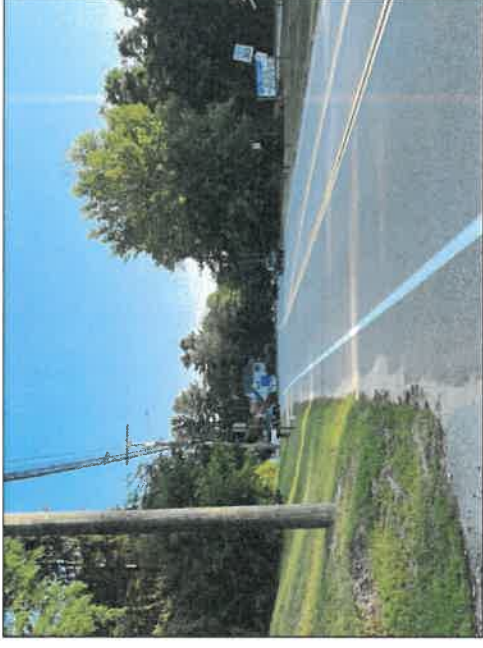
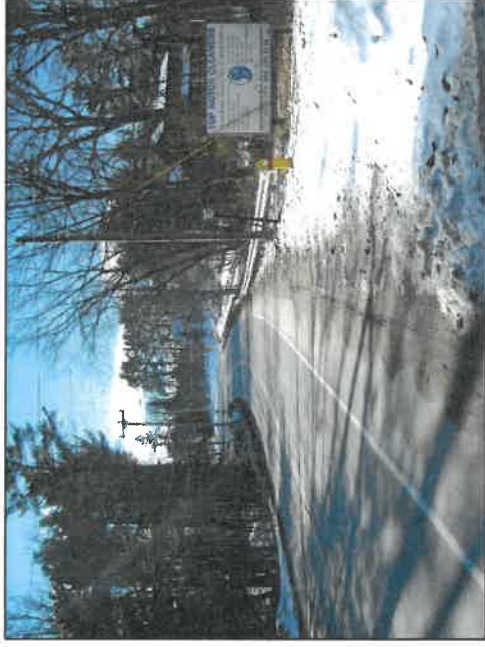
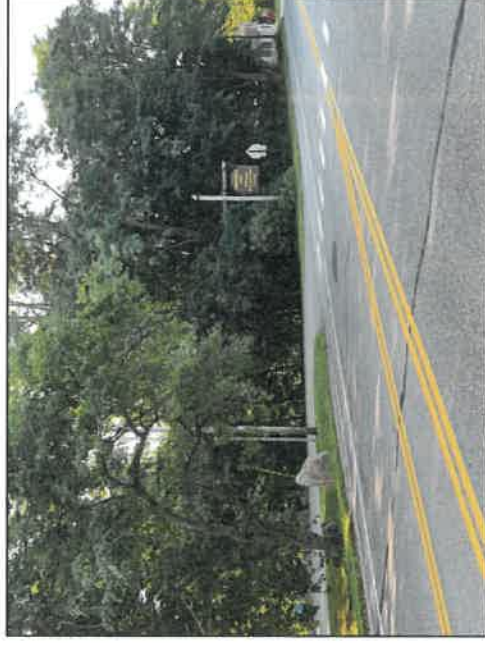
- Scoping Session
  - Design Criteria
  - Existing Conditions
- ✓ Existing Traffic Equipment Surveyed
